The Lefkandi-Toumba building as a timber-framed structure

Alexandra Coucouzeli, Allan McRobie, Igor Kavrakov,
Dimitrios Raptis

The article demonstrates that the building or megaron on the Toumba hill at Lefkandi (Euboea), dating from c.950 BCE, was a timber-framed structure, in contrast to the common view of it as a building with load-bearing walls. This raises the possibility that the walls, perhaps even parts of the frame and the roof, were still under construction, rather than fully completed as previously assumed, when the building was buried under a mound. The reconstruction of the building as a timber-framed structure, as well as an analysis of the manner of production of its wooden elements and a structural analysis intended to test the integrity of the frame point to a sophisticated and solid structure, giving us valuable insights into ancient wooden architecture and the complex rationale behind the adoption of designs of this kind as prototypes of later large-scale temples in Greece. There is no evidence that the timber frame suffered any significant structural failure, but if such failure ever occurred, it would most likely be a partial uplift of the thatched roof due t

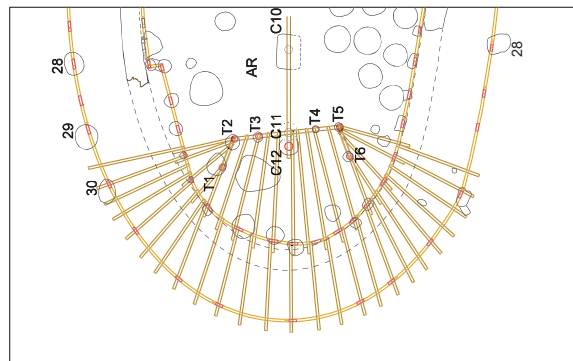
Fig. 6. Reconstructed plan of the roof with principal rafters (in brown) superimposed on the existing plan (in black). Insets A-D: principal and common rafters in three different parts of the building.

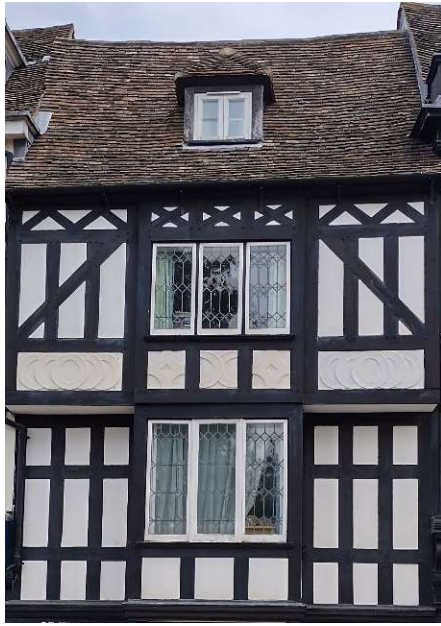
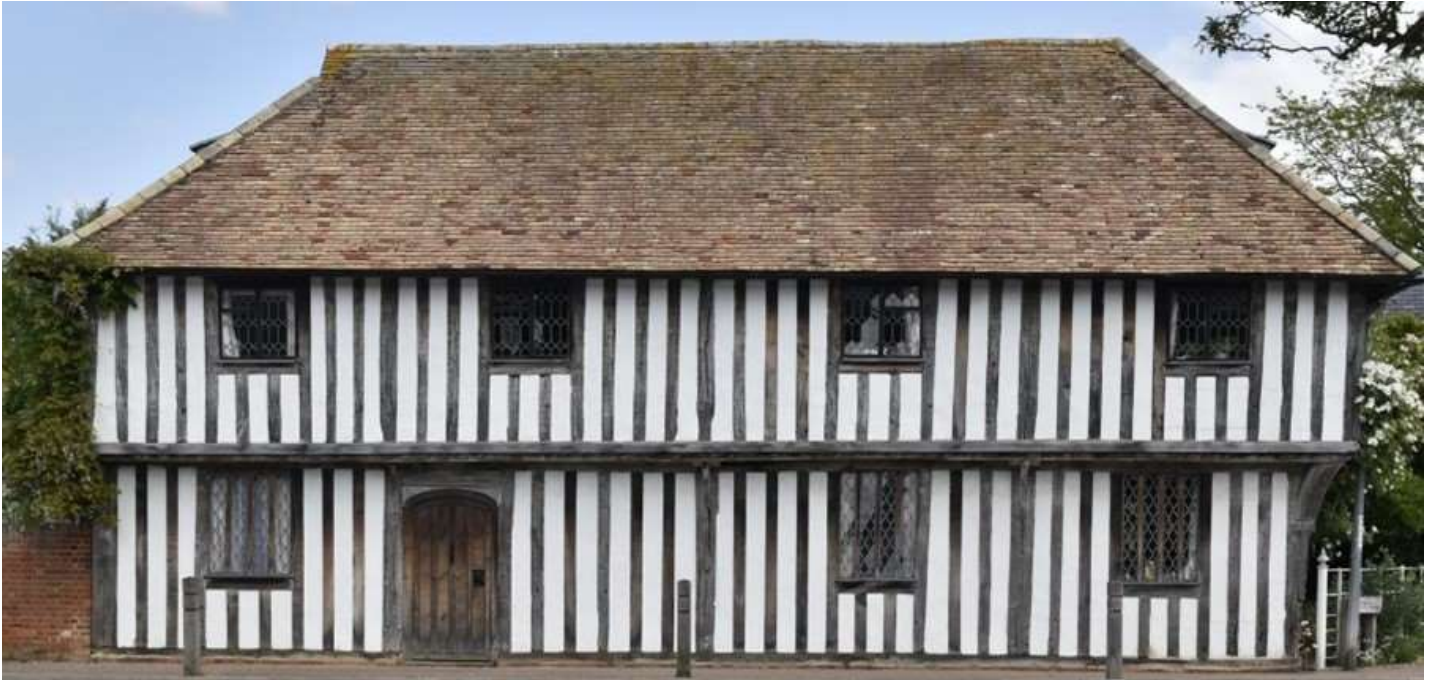
Fig. A1:15. British timber-framed buildings with (a) square panels in Cambridge, U.K. (photo by the author); and (b) vertical panels ('close-studding'): (b1) in East Anglia, mid-16th century (adapted from Harris 1979, fig. 31) and (b2) in Whittlesford, Cambridgeshire, early-16th century (photo courtesy of Gustavo Milstein ARB).

⁴⁶ Close-studding is a distinguishing feature of timber-framed buildings in East Anglia, where the maximum spacing of the studs is 0.60 m (Harris 1979, 23, 61, 80, figs 17, 29, 31, 41). This answers Schattner’s objection that the vertical lines are too closely set to be attributable to timber-frame construction (*Fachwerk*) (Schattner 1990, 136). Schattner also points out here Brockmann’s objection (Brockmann 1968, 21) that the lines in question do not take into consideration the small triangular windows in the upper part of the walls (Schattner 1990, 136); in fact, however, in close studded timber-framed buildings, the series of studs can be interrupted by windows (e.g. Harris 1979, fig. 31). It must be pointed out that Schattner (1990, 131-2 with n. 143) distinguishes erroneously between *Fachwerk* (timber-frame construction) and what he calls *Mischbauweise* (mixed construction), with the former

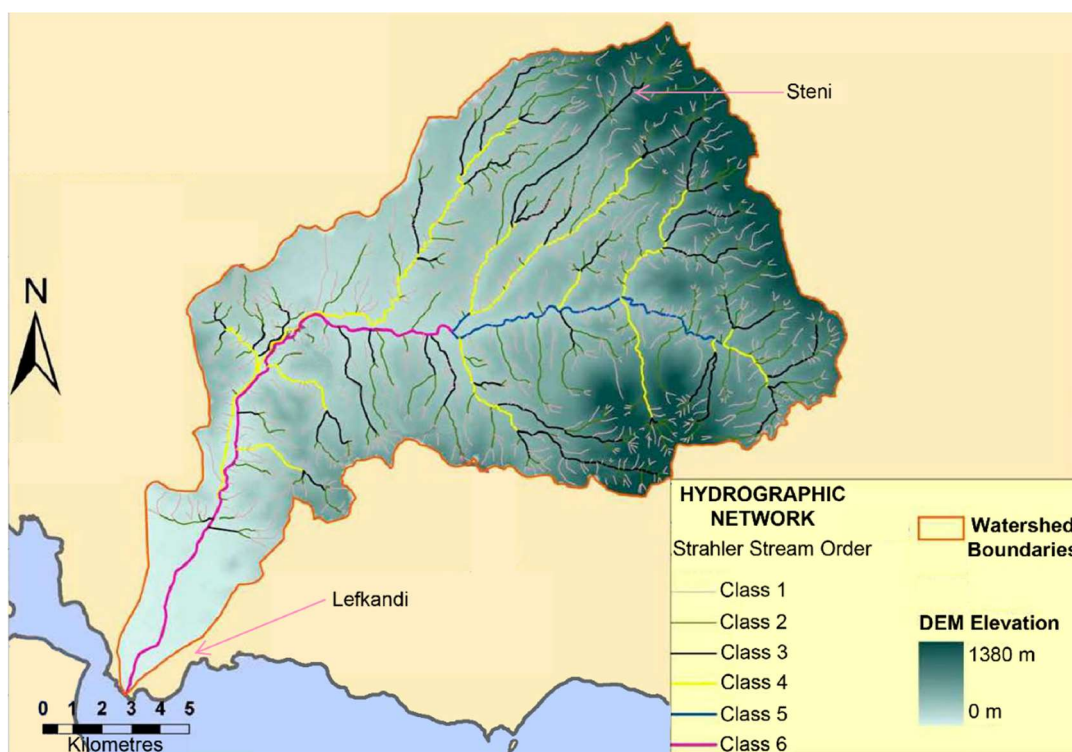
Fig. A2:2. Hydrological basin and hydrographic network of the Lelas River (adapted with kind permission from Katetsiadou 2011, map 12).

⁶⁵ Katetsiadou 2011, 22-3, maps 11, 12, 22, 26. The part of the river near Steni, which is classified as Class 3 of the Strahler stream order (Fig. A2:2), would have been able to carry the logs during the winter months (K.-N. Katetsiadou, pers. comm.).

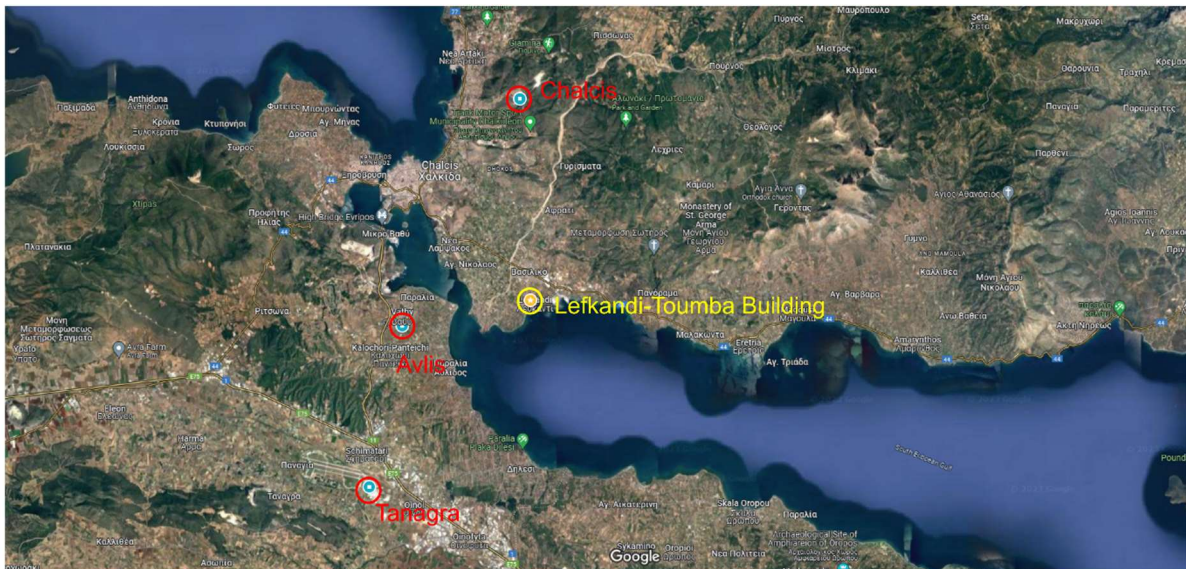
Fig. A5:1. Satellite image of the Lefkandi-Toumba site and the three nearby weather stations of Aulis, Chalcis, and Tanagra (Source: Google Maps).

In our study, we used historical data on the mean wind speed provided to us by the Athens National Observatory (NOA) Near the LK-T building site, there are three weather stations that could be considered as representative: Aulis, Chalcis, and Tanagra (see Fig. A5:1).¹¹ Of these, we chose the stations of Chalcis and Tanagra. Both are located on relatively open terrain: the former is on a hill, above the neighbouring town of Chalcis, the latter on the airport of the nearby town of Tanagra, which ensures that no surrounding buildings influence the wind field. The weather station of Aulis was excluded, because it is located on top of a low-rise building, and it is suspected that the data is influenced by the local aerodynamics of obstacles, in turn influencing the measured wind speed.¹²

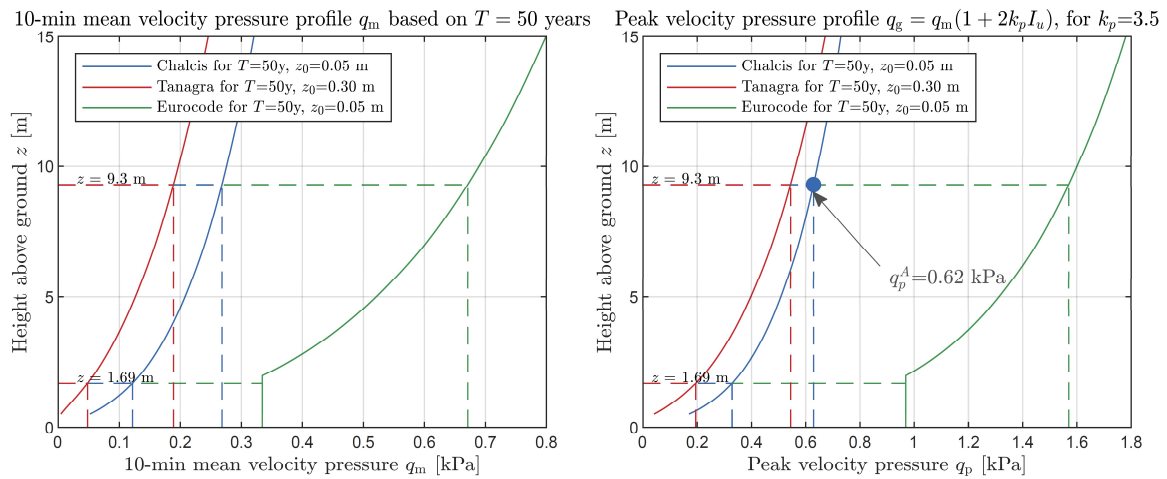
Fig. A5.4. Boundary layer of 10-min mean (left) and peak velocity pressure (right) for a return period of $T=50$ years. The dashed lines indicate the lowest and highest elevation of the (reconstructed) roof of the LK-T building. The peak action velocity pressure q_p^A is taken as a governing action.

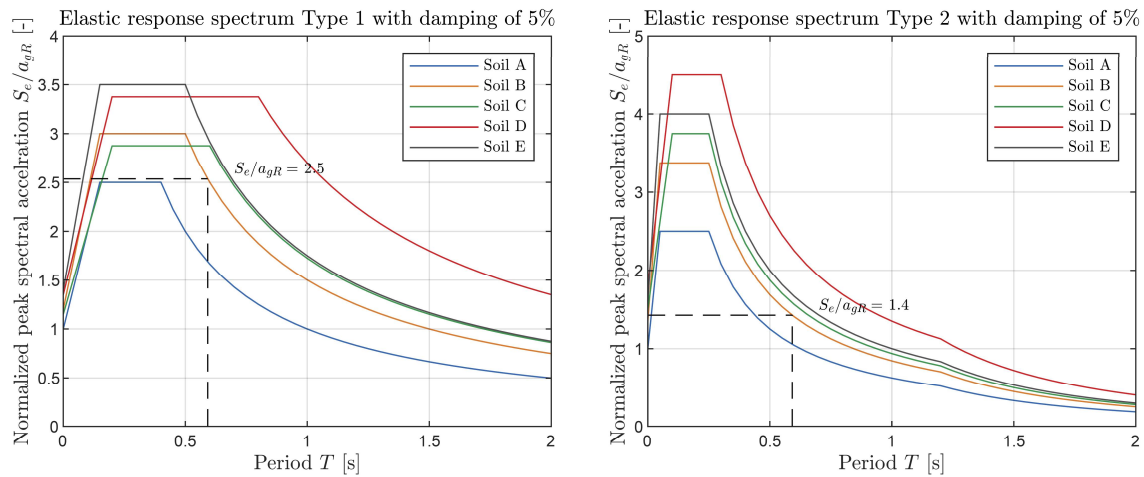
Fig. A5:9. Elastic response spectrum for 5% damping, based on Eurocode 8: Type 1 – surface-wave magnitude greater than 5.5 (left) and Type 2 – surface-wave magnitude lower than 5.5 (right).
