The Lefkandi-Toumba building as a timber-framed structure

Alexandra Coucouzeli, Allan McRobie, Igor Kavrakov,
Dimitrios Raptis

The article demonstrates that the building or megaron on the Toumba hill at Lefkandi (Euboea), dating from c.950 BCE, was a timber-framed structure, in contrast to the common view of it as a building with load-bearing walls. This raises the possibility that the walls, perhaps even parts of the frame and the roof, were still under construction, rather than fully completed as previously assumed, when the building was buried under a mound. The reconstruction of the building as a timber-framed structure, as well as an analysis of the manner of production of its wooden elements and a structural analysis intended to test the integrity of the frame point to a sophisticated and solid structure, giving us valuable insights into ancient wooden architecture and the complex rationale behind the adoption of designs of this kind as prototypes of later large-scale temples in Greece. There is no evidence that the timber frame suffered any significant structural failure, but if such failure ever occurred, it would most likely be a partial uplift of the thatched roof due t

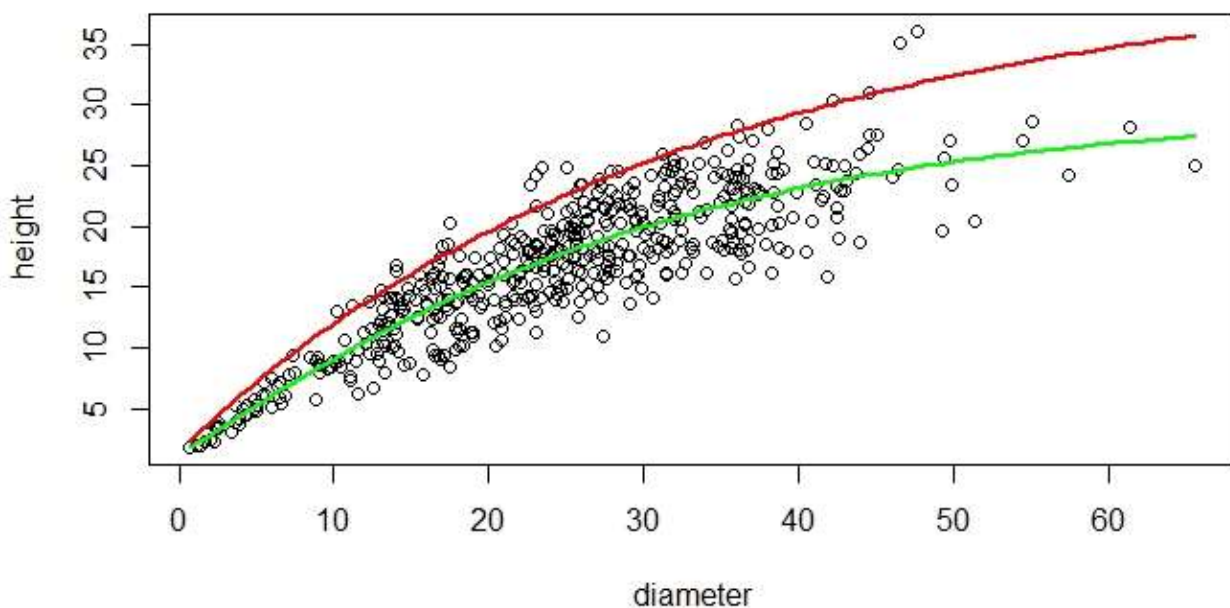
Fig. A2:3. Graphical representation of the mean (green line) and the maximum (red line) height curve against the diameter at 1.30m for *Cupressus sempervirens* var. *horizontalis*.

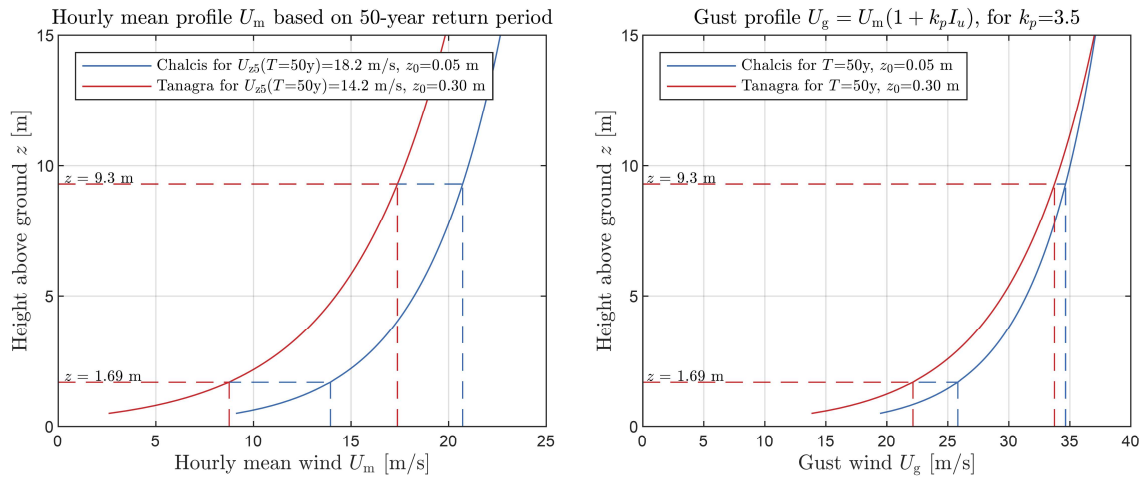
Fig. A5:3. Boundary layer of hourly mean (left) and gust wind speed (right) for a return period of $T=100$ years. The dashed lines indicate the lowest and highest elevations of the (reconstructed) roof of the LK-T building.

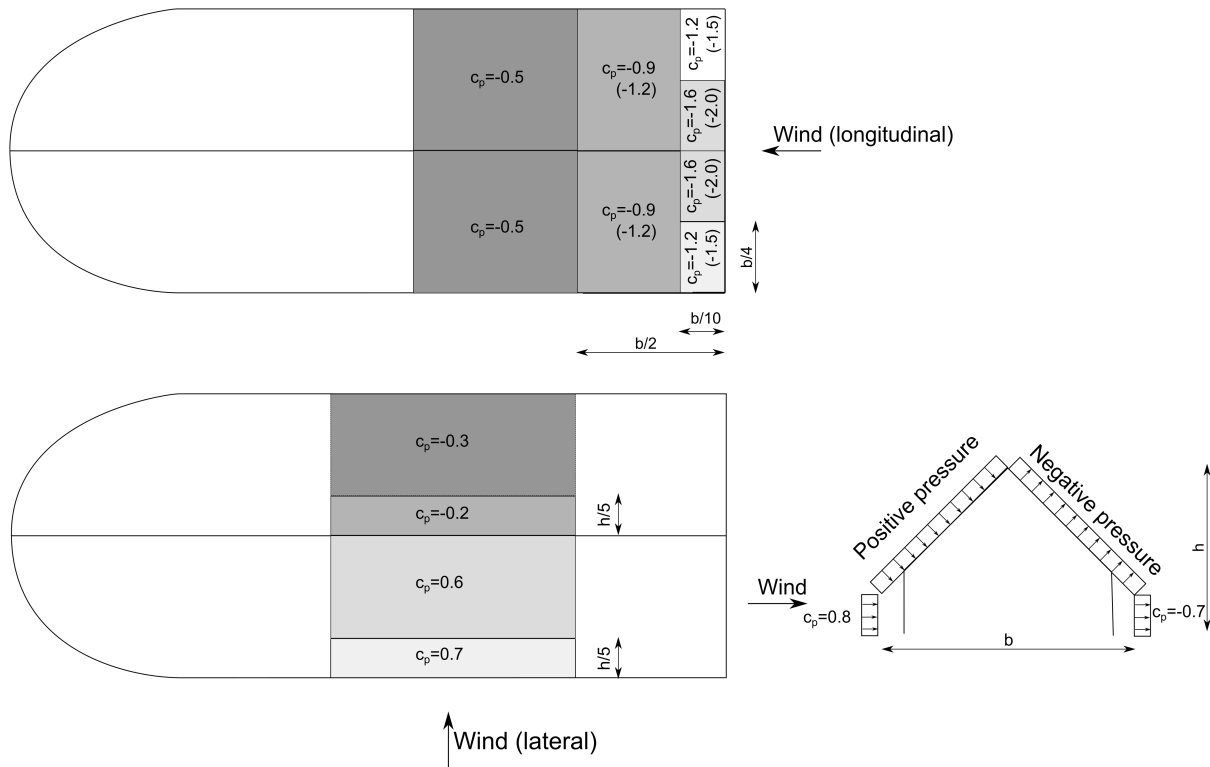
Fig. A5:5. External pressure coefficients according to Eurocode 1 for wind perpendicular to the short end of the LK-T building (top) and to the long end of the building (bottom). The values outside of brackets are for elements with an area of 10m^2 , while the values inside brackets are for elements of 1m^2 . Drawings not to scale.
