Al-Andarin/Androna: Site and Setting

Christine Strube

The following report will focus on the situation of Androna in the 6th to 8th century, that means, on the question of continuation and discontinuation in early Byzantine and early Islamic times.

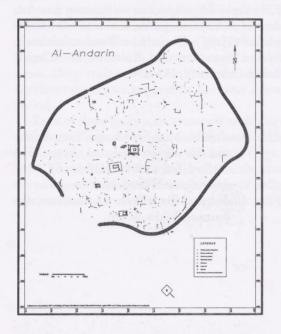
Fig. 2 Androna: Plan of the site.

The field project started in 1997 with the geodetical elevation of the site (Figs. 2. 36), and excavations began in 1998 as an international collaboration of a Syrian, British and German team, trying to clarify the development of the site from Roman to Byzantine and into the Early Islamic periods through the study of the defensive organisation and monumental layout, the water supply and the agriculture of Androna. The results for the baths in the centre - the Byzantine one excavated by the British, the early Arabic by the Syrian team - and the study of the kastron - the two circuit walls and the house-architecture by the German team - allow a first insight into ancient and medieval Androna⁴. For the comprehension of the monumental layout of the site it is important, that the buildings of Androna are standing on limestone. The mass of basalt stones found in these buildings had to be transported over long distances to Androna⁵.

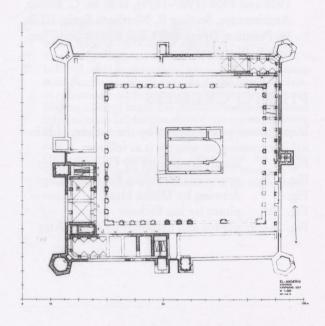
Fig. 4 Androna, Ground plan of the Kastron.

The *Kastron*, dated to 558–559 AD and sponsored by Thomas, a citizen of Androna⁶, covers an area of about 6000 square meters (Fig. 4). It is closely

linked to the buildings of Qasr ibn Wardan and to the great Syrian cities and at the same time deeply rooted in local tradition. The ground plan shows a door flanked by towers on the west- and south side (Fig. 3), two great ramp-houses⁷ connecting the double storied living and working rooms, arcades carried on piers surrounding the inner court and a church in its centre, which was not part of the original building concept⁸. I will concentrate on the intensive reuse of the *kastron* in the early Islamic time, which informs about the situation of the centre after the 6th century. I select the southwest part of the building.

The ground floor of the west hall (Fig. 4) -

15,30 m long, 7,80 m broad and at least 6,30 m high - was originally covered with cross vaults and opened in full height to the loophole way. Some of these openings were closed in Islamic time by mudbrick walls and the hall was subdivided into three rooms (Fig. 9). To one of the mudbrick walls, constructed between the pillars and their opposite, we owe the preservation of the Annunciation scene with Gabriel and St. Mary (Fig. 11)9. The presence of this scene in a room that was originally used for communal purposes was surprising. Unexpected was also the situation in the eastern tower, flanking the south gate of the kastron: fallen mudbricks protected a small section of a wall with paintings of early Islamic time (Fig. 12)¹⁰. Smallfinds provide first information about the different phases of reuse and their chronology, further information gives the horizon of destruction of the kastron: The latrina south of the western hall (Fig. 4), which offered place for about 20 persons¹¹ – as well as the great south hall were reused only during a shorter period – up to the 9th century maximum. These were destroyed by a fire12, which also destroyed a greater part of the west hall. The section with the pillar showing the Annunciation was not in use after the 9th century, only the northern part of the west hall could be reused until the 14th century.

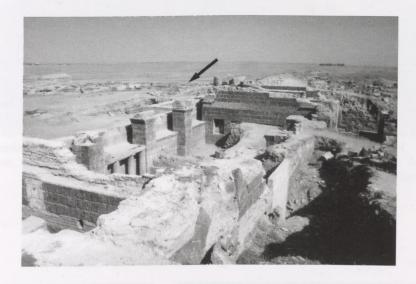
Fig. 6 Androna, Kastron: the excavated western part with the west gate (arrow).

The situation at the beginning and the end of our excavation (Figs. 5. 6: the white arrow points to the lintel of the west door) illustrates, that the rooms of the ground floor are standing up to about 6 meters, filled not only by a mass of materials from the upper rooms, but also by constructions of Islamic times. The west hall is reached through the huge vestibule of the west door (Fig. 7) and the western ramp-house (Fig. 8), which leads to the upper rooms as well as to the

loophole way, running around the whole building (Figs. 6. 9).

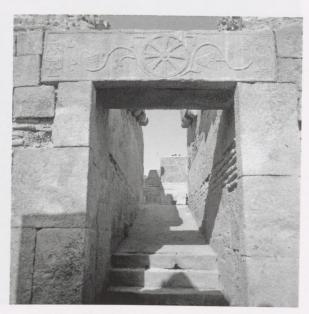
Fig. 8 Androna, Kastron: the western ramphouse with its eastern entrance-door.

In each ramphouse at least one course of the ramps began with three steps (Fig. 8).

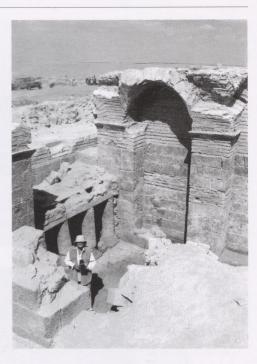
Fig. 10 Androna, Kastron: northern part of the great southern hall.

The good preservation of the south hall (Fig. 10)¹³ and the dense information of the collapsed vaults of its upper rooms (Fig. 13) we owe to this early destruction¹⁴. The marble column with its limestone capital (Fig. 14) closely connected with the best north Syrian workshops¹⁵, leads to a further aspect of the kastron: the rich spectrum of imported materials¹⁶. In the upper rooms we find red and green porphyr and different kinds of marble for revetments as for opus sectile and glass-mosaic¹⁷. They testify to an intensive import of precious materials - the broad spectrum of decoration in basalt completes the picture (Fig. 15)¹⁸.

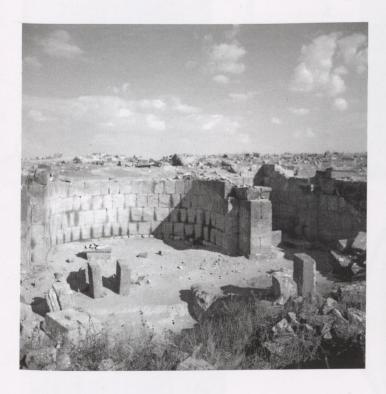
Fig. 20 Androna, Kastron: church in the court looking southeast.

The church in the court of the kastron, which is a later addition with another donor and without the characteristic masonry of the kastron (Fig. 20)19, shows, that the broad spectrum of materials was not only characteristic of the kastron. The interior of the church was deeply destroyed, but we could clarify the main features: The interior arcades were supported by limestone capitals on 'brescia' columns²⁰ - not by pillars, as Butler had supposed²¹. The interior of the church presented a colourful view with its marble revetments, its opus sectile in porphyr, different kinds of marble and natural stones and its limestone capitals on 'brescia' columns, covered by heavy basalt blocks - it is the coloured picture of the church of Q. Ibn Wardan (Fig. 21)²², repeated in the south church and the church of the archangels in Androna²³ and certainly also in other churches of the region.

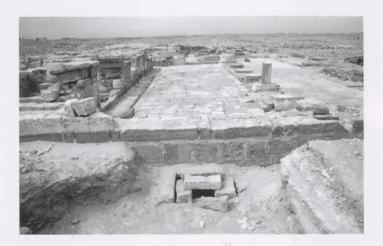
Fig. 25 Androna, early Islamic bath, the northern part.

namely: The reception hall, which was divided into two compartments by a long row of arcades on columns (Fig. 25). The southern half of the bath (Fig. 26) was constructed in local limestone the first greater construction in Androna, which used the local stone -, whereas the northern half was completely built in spolia of basalt and reused are also the marble revetments²⁹. The great number of lintels as the mass of spolia in general informs about the situation of the centre at the time, when the bath was built: Not only the Byzantine bath, but also a greater number of houses and other buildings had been damaged or were out of use30. Nevertheless evidence of the bath suggests a certain degree of continuity of the settlement at the site - the excavation of a house near the inner circuit wall confirms this assumption.

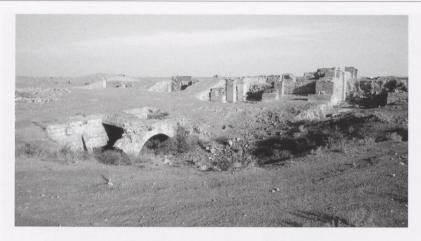
Fig. 27 Androna, House. The reservoir and the house looking northwest.

The aerial photograph taken by Georg Gerster in spring 1997 (Fig. 1)³¹ shows a building-complex with a court on the northern (Fig. 29) and a great reservoir in front of the southern side (Fig. 27). We began our studies with this house, which lies inside and quite close to the inner circuit wall. We hoped to gain information about an advanced phase of the settlement³².

From east to west one can observe the following (Figs. 27. 29. 31)³³: A huge eastern hall with transverse arches, a long southern porticus, which connects the eastern and western part of the house, a corresponding northern porticus, which opens towards the rooms around a large stable-room (Fig. 28), a great reception-hall at the eastern end of the northern porticus with a rich mosaic floor (Figs. 29. 30). The door in the middle of the south side opens towards a long vestibule, which separates and simultaneously connects the two halves of the building-complex Figs. 29. 31). The porticoes as the rooms of the eastern part of the house were double storied, two rooms of the western half may have been single storied. The different parts of the building were covered by saddle or lean to roofs.

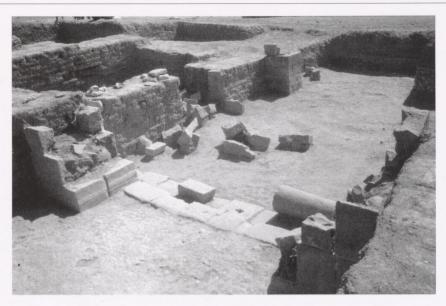
Fig. 34 Androna, Outer circuit wall. A gate in the southern sector of the wall.

The gates of the mudbrick wall, also built in quadrated basalt blocks, flanked by mudbrick towers and with an outer and an inner vestibule (Fig. 34) follow in their general layout the type of the west gate in the wall of Dura Europos⁴³. The bulk of the ceramics belongs to the late 5th and 6th centuries, a smaller part to the 8th–10th century (Figs. 16. 17) – the towers were reused in Islamic times. Deep traces of cars on the door sills of the north-western gate suggest its use over a longer

So far, we have been able to clarify the following: There are serious hints, that not the outer, but the inner circuit wall is the older construction (Fig. 33). This inner wall was a huge building project with its mass of quadrated basalt stones and it remains an open question, whether it was ever finished⁴¹. Geophysical prospection provided first evidence that the inner wall came out of use during the 6th century⁴². This was confirmed by the excavation of a northwest and a south gate of the outer wall (Figs. 34. 36).

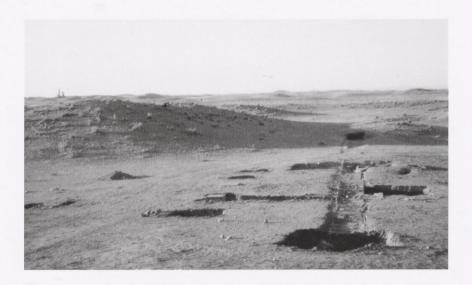
Fig. 35 Androna. Street starting at the northwest gate of the outer circuit wall.

Each of these gates was connected with a street, which was flanked perhaps on only one side by a porticus and led to the centre of Andarin (Figs. 35. 36)⁴⁴. The situation of the inner wall in the area of the two gates is of great interest: Some of its huge quadrated stones were reused in the south gate and

In 2006 I could reconstruct the course of the street starting at the north-western gate up to the Arabic bath. Our limited excavation work brought no evidence for two porticoes, flanking a central street. The surface situation of Androna contains much information about a real system of streets. Its reconstruction demands intensive geophysical prospec-
