Zafar, Capital of Himyar, Ninth Preliminary Report, September-October 2010¹

Prof. Dr. Paul Yule, 07.11.2010, Heidelberg, (10 field report)

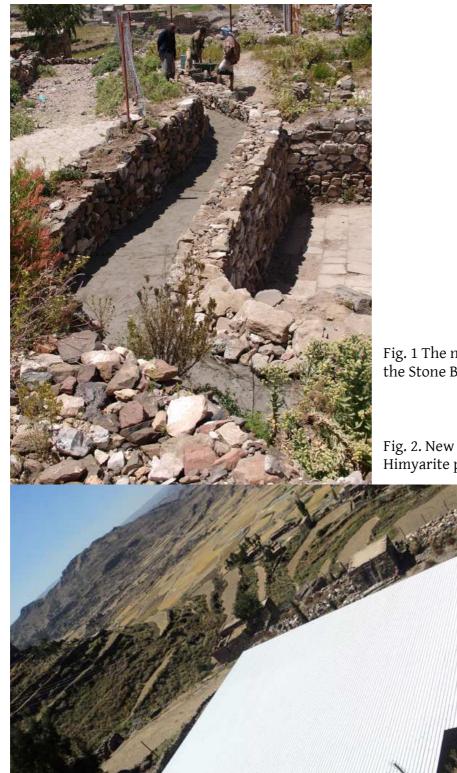
Fig. 1 The new water channel in the Stone Building.

1 Conservation Measures for the Himyarite period Stone Building site in Zafar The task of protecting an antique monument in perpetuity is a tall order. Having excavated the Stone Building, in 2007 and 2008 we proposed to GOAM (General Organisation for Antiquities and Museums) to re-bury it in order to improve its chances for survival. Those responsible did not take this advice to heart. Daily fluctuations in the temperature and humidity adversely affect the condition of the excavated remains. To get more precise information about such factors, in 2009 the restorer Prof Dr Michael Pfanner (Munich) visited the site for a week and prepared a conservation plan. Thereupon, this year we built a gutter to conduct rainwater which flows into the ancient building area from the east back out again (Fig. 1). This reduces the fluctuations of water upon the building and its reliefs, but does not eliminate them completely. Our main goal was to roof the entire surface which we excavated (28 x 30 m) during our stay which was finished a week after our arrival back home (Fig. 2 and 3).

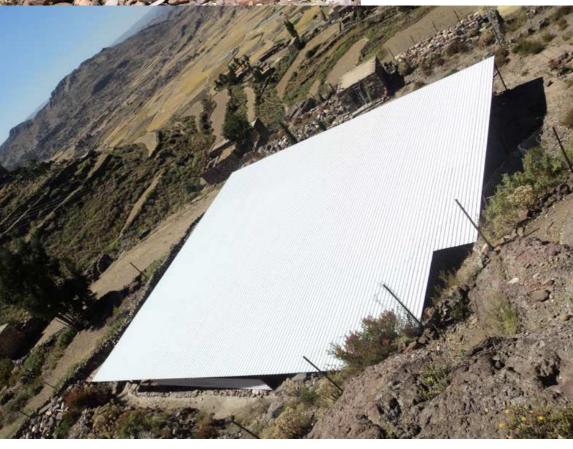
Fig. 2. New roof over the entire Himyarite period Stone Building.

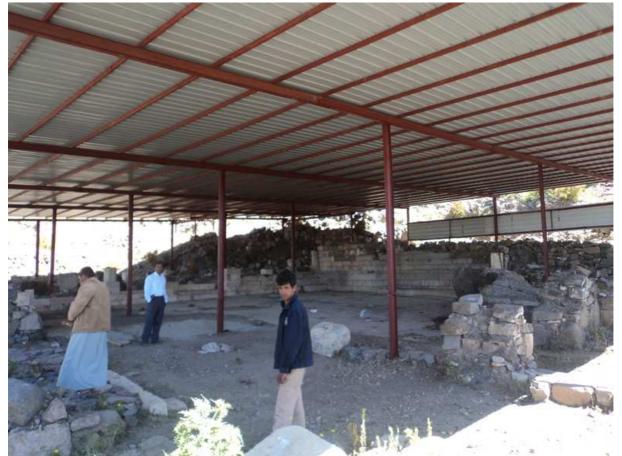
Fig. 3. New roof over the entire Himyarite period Stone Building.

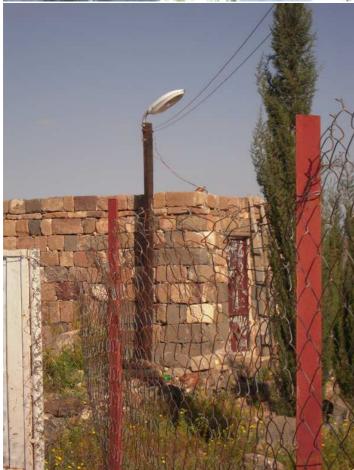
Fig. 4 New floodlighting in the Stone Building area.

A second main problem is the security of the area owing to vandalism and clandestine excavation. Finds are being removed from the excavated area. The lack of illumination exacerbates an already unfavourable security situation. Given the poor pay of the guards, they may not always be motivated: For this reason, the roof which we erected in 2008 over the eastern relief wall has been vandalised. The undersigned decided to illuminate the 50 x 50 m excavation area by means of two floodlights. First, we tapped a nearby electrical main for our power supply and set up two electrical masts. The floodlights are positioned on the southern and western sides (Fig. 4). In order to make the guards' house (which we built in 2008) more comfortable, this year we supplied mattresses, blankets, pillows and electrified it. In addition, we repaired the roofs of this house and our magazine which leaked.

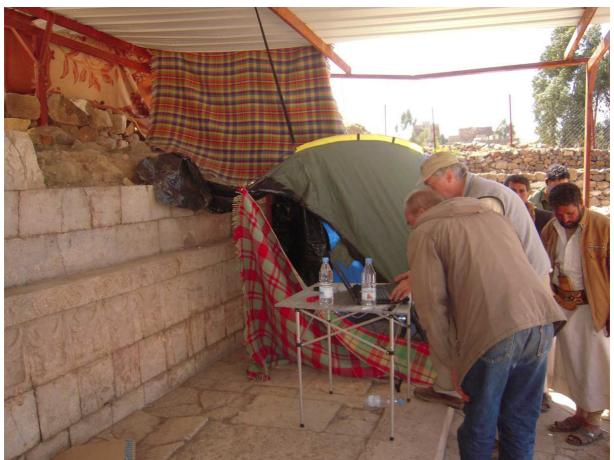
Fig. 5 As part of our conservation programme at Zafar, J. Lindenbeck documents the 15 m long Himyarite period relief wall by means of a 3D scanner.

This year we recorded the Himyarite period reliefs of the eastern interior courtyard wall by means of a 3D scanner (Fig. 5). Our annual photography revealed their alarming degrading exposed to the elements. Our photos proved insufficient for an accurate rendering of the reliefs. Once assembled, the resulting scans will offer a high resolution 3-dimensional rendering of these unique and endangered works of art. Such 3D images are far more accurate than the simple normal and rectified photos which we took in previous years, and are to appear in the final publication.
